### ***Arborist Report: Tree Assessment***

**Date:** February 28<sup>th</sup>, 2020  
**To:** Scott Cannon  
**From:** Chris Rippey, Rippey Arboriculture LLC  
**Subject:** Sonic tomography and resistance drill assessment of a coast redwood tree in Seattle, Washington

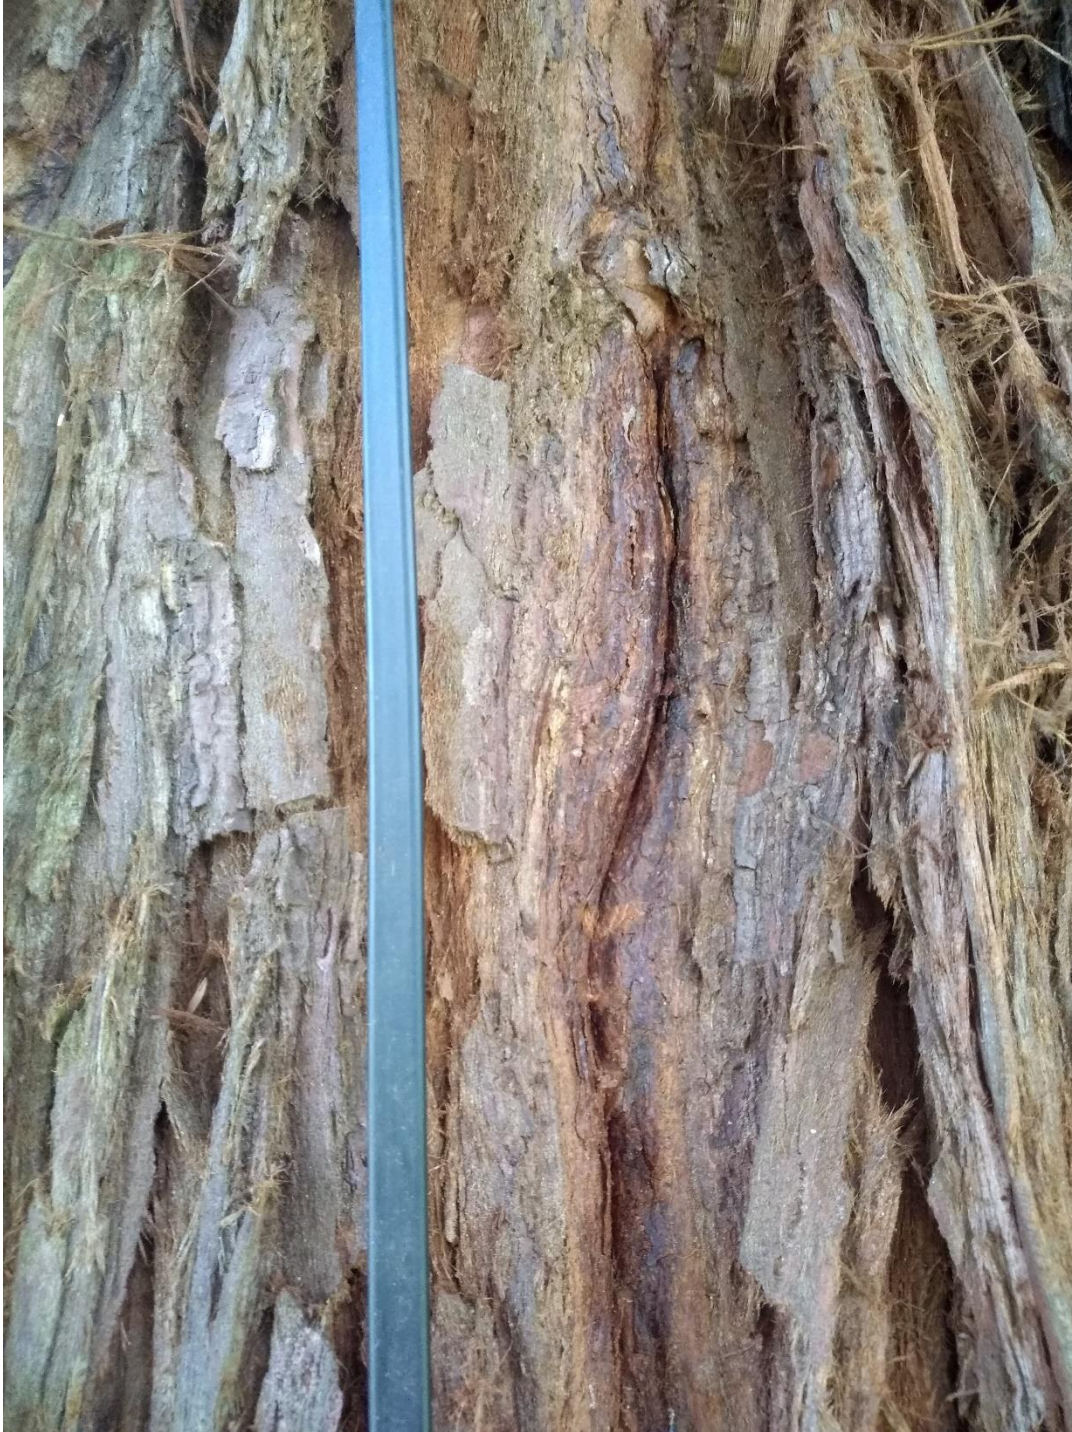
The tree has two main trunks that diverge from the main trunk at about 6 feet high from grade. There is included bark on the east and west side where the trunks diverge. The west side of this attachment appears to have recently separated (Figure 1). There is also a large amount of reactive wood growth on the east side of the attachment (Figure 2). Both main trunks diverge at about 20 feet high where they form a total of five separate trunks.

***Figure 1: Attachment separation with included bark on the west side of the trunk at six feet from grade.***

Because no reasonable mitigation option was found, it is my recommendation that this tree be removed due to the tree's architecture, strength loss due to internal wood decay and trunk separation.

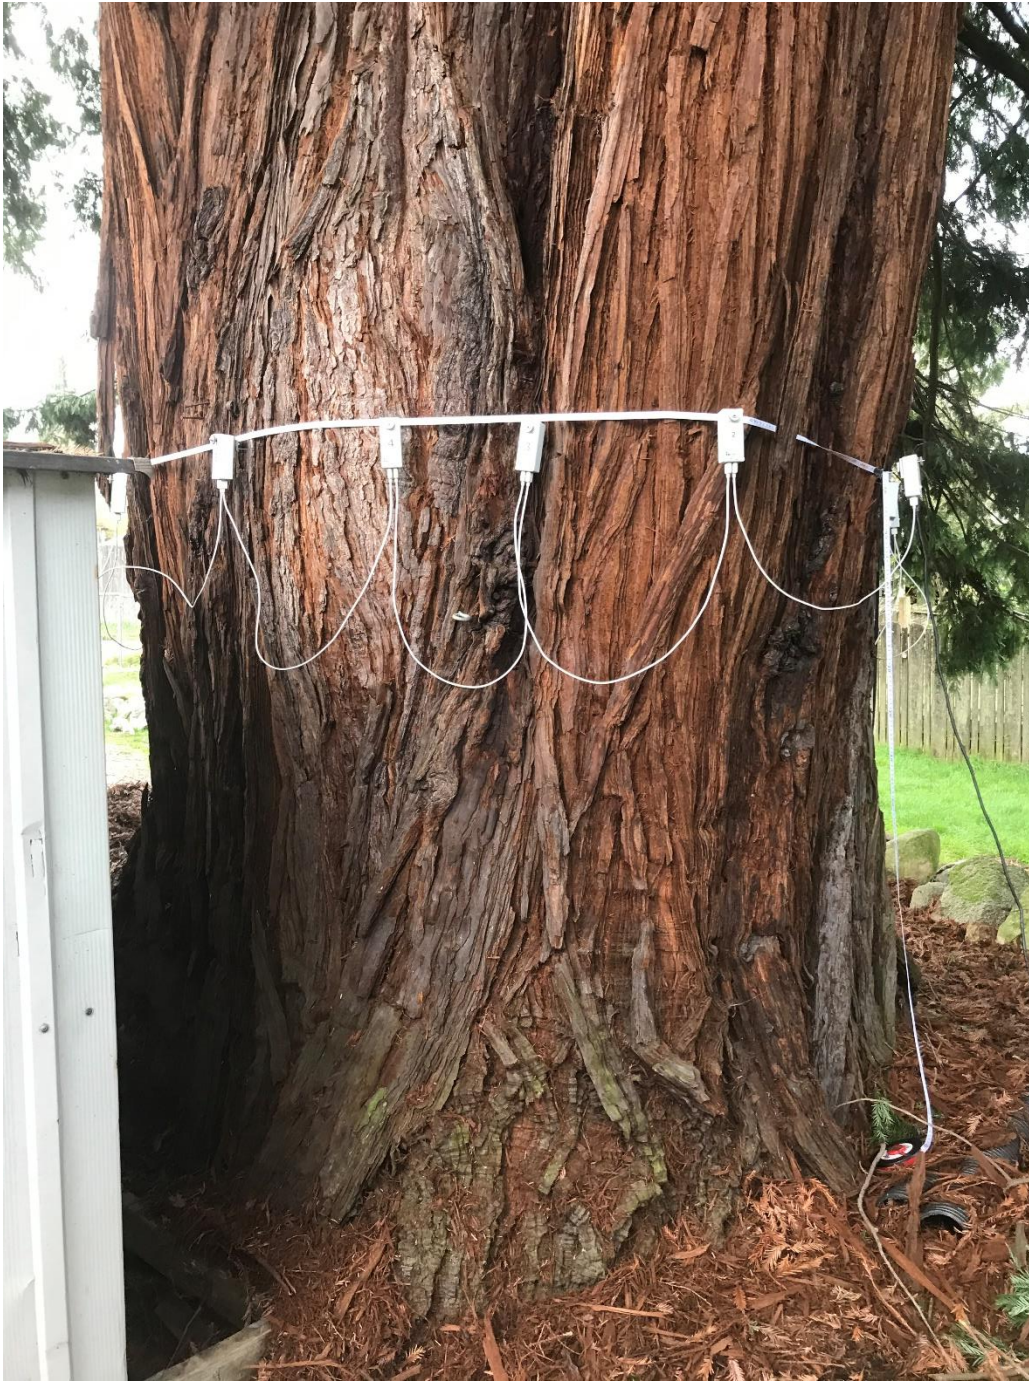
This tree has extensive internal wood decay that has caused a significant loss in strength. There is significant internal wood decay and strength loss where this tree diverges into two main trunks. There is included bark where these two main trunks attach as well as a section on the west facing trunk where the attachment is separating. There are large amounts of reaction wood on the east side of this attachment. This wood has been grown as a reaction to that strength loss due to decayed internal wood.

*Figure 2: East side of the attachment with large area of reaction wood growth shown left of center.*

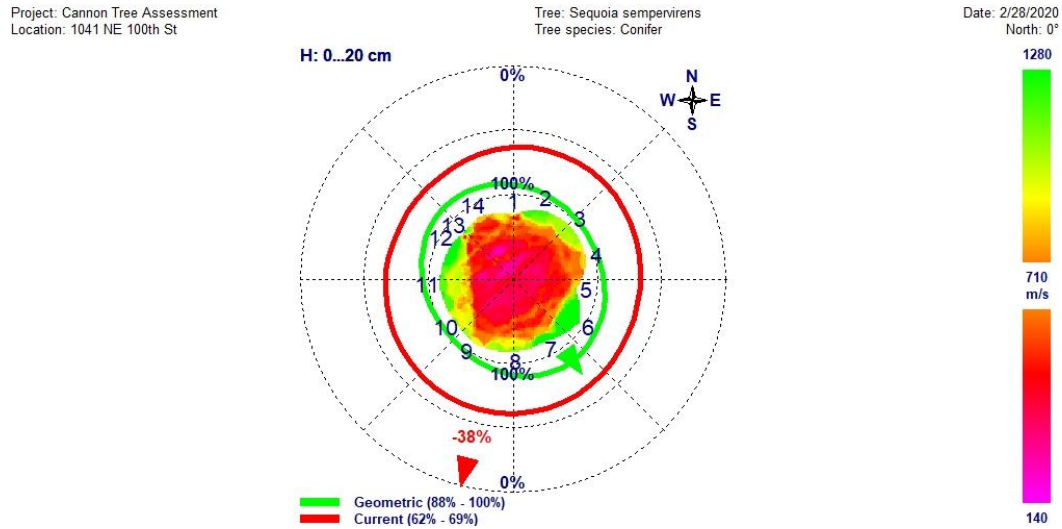
The results of the lower test site (Figure 3) indicate a significant amount of decayed wood including a large hollow area in the center of the tested cross section of tree trunk. Non-decayed wood is indicated to be in the northeast, southeast and west quadrants. Based on the type of tree wood, shape of the cross section and the

location of decay, a 38% loss in load carrying capacity (strength) has occurred.

**Figure 3:** Result from Rinntech ArboTom, sonic tomography assessment. Results taken at 20 centimeters from grade and indicate that the tree has lost 38% of its load carrying capacity (strength) when forces (winds) are applied from the slightly east of north. This image is on a Green-Purple scale where hollow wood is indicated by a purple color.

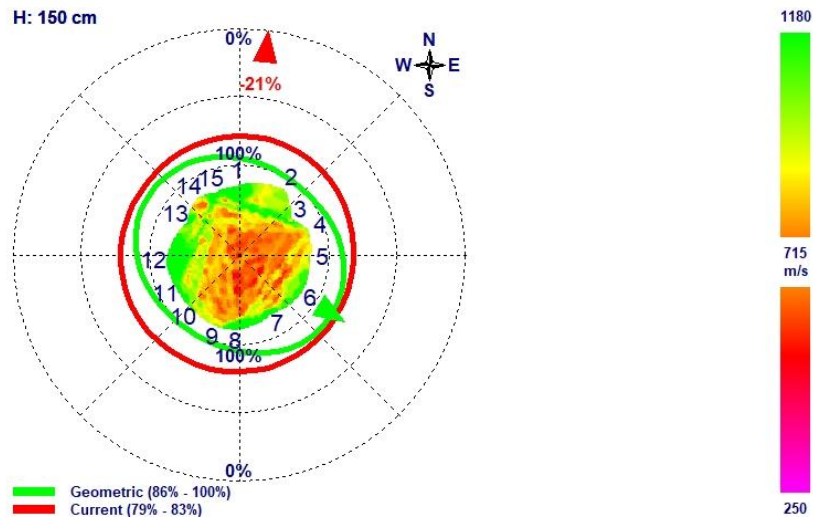
Results from the higher test site (Figure 4) indicates a significant amount of decayed wood. Most decay is incipient decay with some sporadic hollow spots and pockets of severely decayed wood. Significant amounts of non-decayed wood are indicated to be in the north, southeast and west quadrants. Based on the type of tree wood, shape of the cross section and the location of decay, a 21% loss in load carrying capacity (strength) has occurred.

**Figure 4:** Result from Rinntech ArboTom, sonic tomography assessment. Results taken at 150 centimeters from grade and indicate that the tree has lost 21% of its load carrying capacity (strength) when forces (winds) are applied from the south. This image is on a Green-Purple scale where hollow wood is indicated by a purple color.

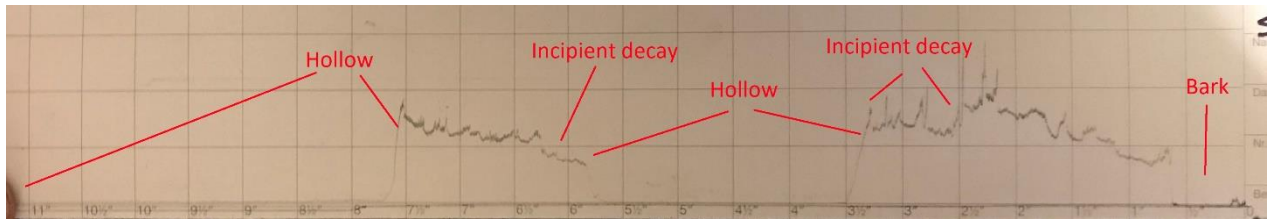
A micro-resistance drill was then used at two places (Figure 5 & Figure 6) along the upper test area to confirm the presence of decayed wood and validate the sonic tomography reading. The first test was taken in between where Sensor 4 and 5 were placed drilling into the tree towards the west. These second test was taken in between where Sensors 7-8 were placed drilling into the tree towards the north. Both tests confirmed internal wood decay that is at the approximate depths of the decayed wood in the sonic tomography images.

***Figure 5:*** Test taken at Sensor 6 site which was 150 centimeters high on the east side of the trunk where the burl/reaction wood is located.

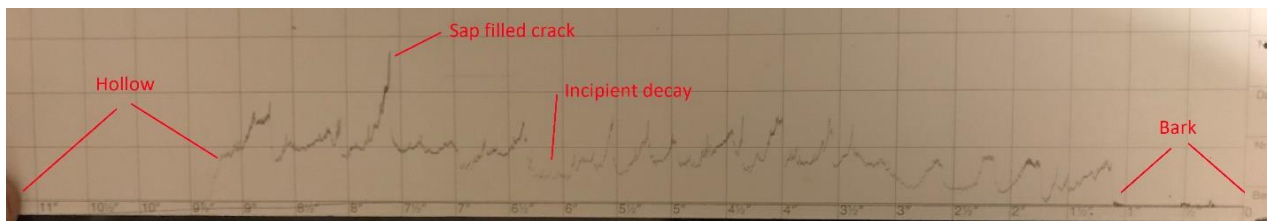
***Figure 6:*** Test taken at Sensor 8 site which was 150 centimeters high on the south side of the trunk.

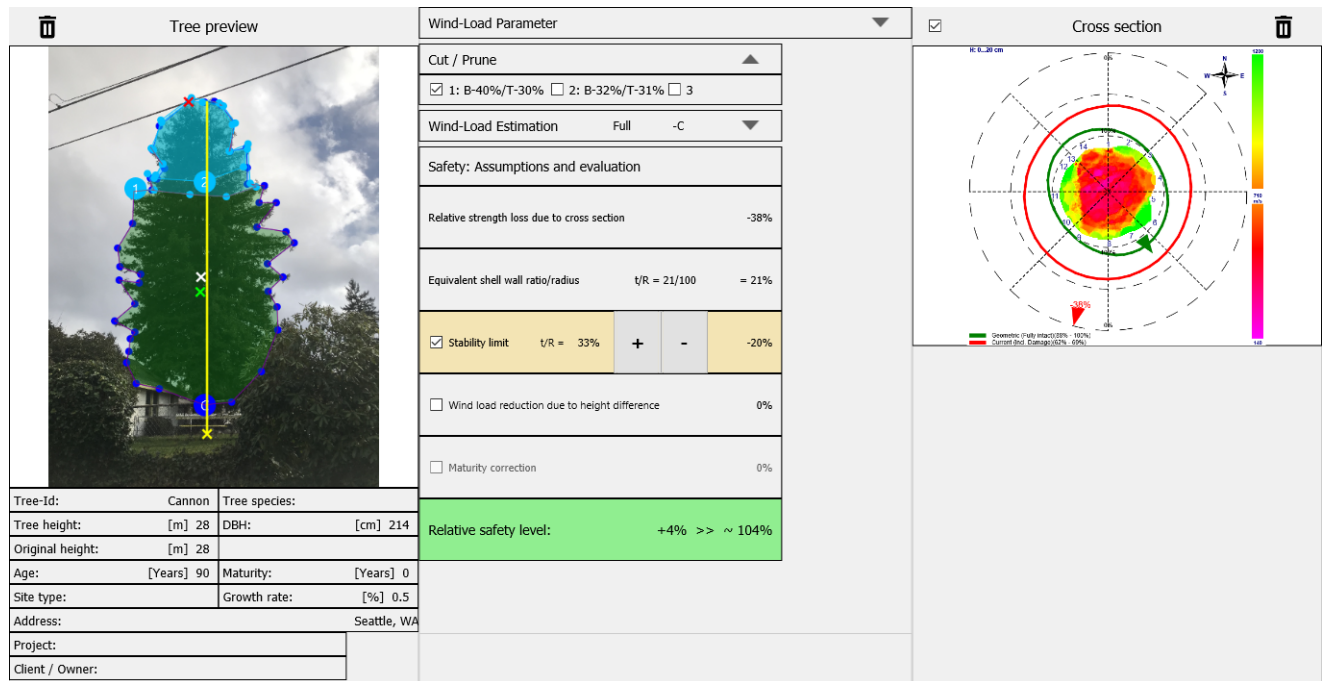
Pruning the tree is also not appropriate due to the extensive amount of canopy that would have to be removed to produce a relatively safe tree. According to Rinntech ArboStApp® modeling (Figure 5), the upper third of the tree would have to be removed to produce a tree that is estimated to support 1.5 times its expected load. Performing such severe pruning would not guarantee structural stability, would cause long-term health issues to the tree and will require expensive long-term maintenance costs.

**Figure 7:** ArboStApp results consider the assessed tree species, diameter, height, age, time of maturity, growth rate, location of decayed wood in the assessed cross section of the tree and wind load. Based on these factors, this tree would have to be reduced in height by roughly 30 feet (see blue area in tree image).
